Subject: Response to WVDEP Comments on Draft Site 11 Remedial  
Investigation for Allegany Ballistics Laboratory,  
Rocket Center, West Virginia

This letter provides to you the Navy's response to your comments provided in your letter of 26 November 2003 on our Draft Site 11 Remedial Investigation, Allegany Ballistics Laboratory, Rocket Center, West Virginia, November 2002. Our response to comments is attached.

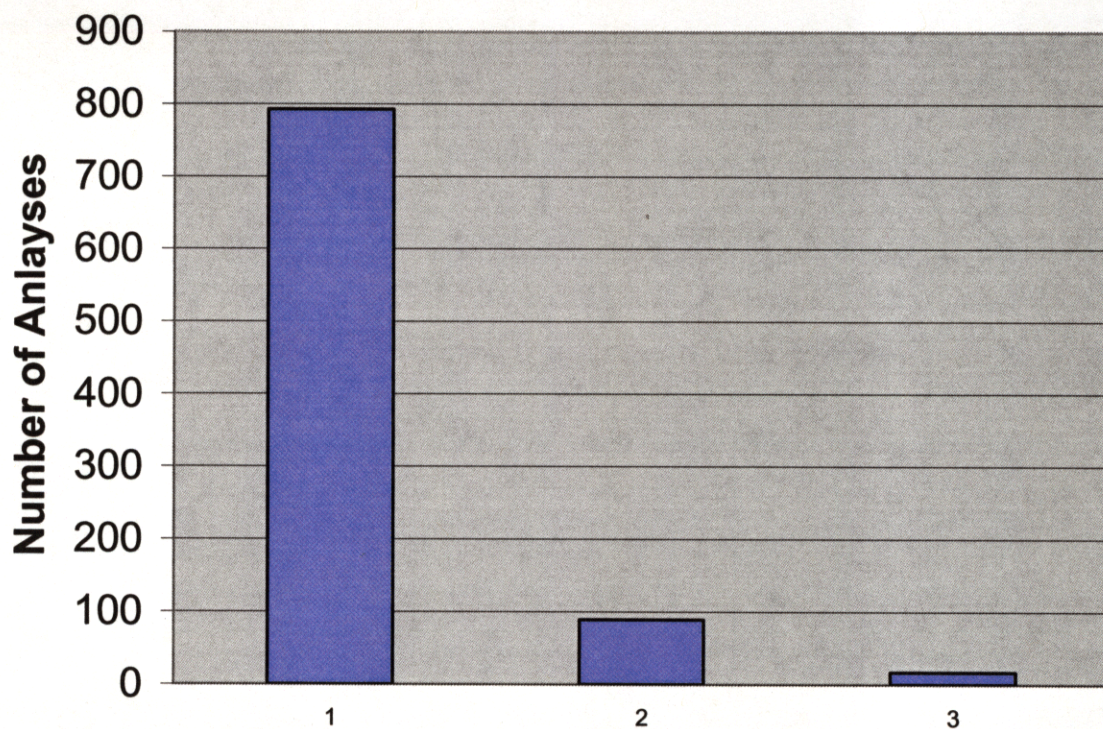
**Figure 1: Dissolved Vs Total Metals Results  
for Site 11 Groundwater**

It is noted that 89 dissolved inorganics results (out of about 790 analyses) were reported at concentrations greater than the corresponding total inorganics results. However, as shown in Figure 1 most of these results (i.e., 72 of the 89) are within the acceptable range of analytical accuracy (+/- 20 percent, as presented in the project QAPP). In addition, the total and dissolved fractions represent physically different samples, and may themselves represent the normal variations in constituent concentrations.

It is important to note that the apparent large-magnitude fluctuations noted in the comment are the result of some data from the 1995 Advanced Site Inspection being incorrectly reported in Table 5-1, not from actual large-magnitude fluctuations in constituent concentrations. The metals data for samples HCW-TP2-1 through HCW-TP6-1 were reported in Table 5-1 in incorrect units and should be lowered by a factor of 1,000 to make the concentrations consistent with the other tabulated results. When the adjustment is made, the resulting concentrations are consistent with those detected during the more recent sampling events. This error in Table 5-1 will be corrected in the next version of this report.

Although there are some variations in the inorganics concentrations over time, they are attributed to the natural fluctuations of the Site aquifer. The groundwater sampling program was designed to assess this variability and therefore comprised four seasonal sampling events conducted during 2000 and 2001 (plus an additional event in 1995). During some sampling periods, the aquifers were under drought conditions. These drought conditions appear to have generally increased the concentrations of inorganics in the groundwater. The human health risk assessment accounts for this natural variation by: (1) evaluating the four most recent sets of groundwater results and using the maximum detected concentrations (worst case) in selecting chemicals of potential concern, and (2) by using the most contaminated monitoring wells or groups of monitoring wells in determining of exposure point concentrations, providing a conservative estimate of risk.
